Inspection Report

Permit Number:	C0070039
Inspection Type:	TECHNICAL
Inspection Date:	Friday, April 01, 2005
Start Date/Time:	4/1/2005 9:30:00 AM
End Date/Time:	4/1/2005 2:30:00 PM
Last Inspection:	Monday, March 21, 2005

Site: **DUGOUT CANYON MINE**

Evaluated four soil trenches at the proposed Pace Canyon fan portal site. Collected samples for analysis of baseline parameters from undisturbed soils and for acid/base potential analysis of coal waste. Undisturbed soils at the site could yield 36+ inches of soil from the combined A and B horizons.

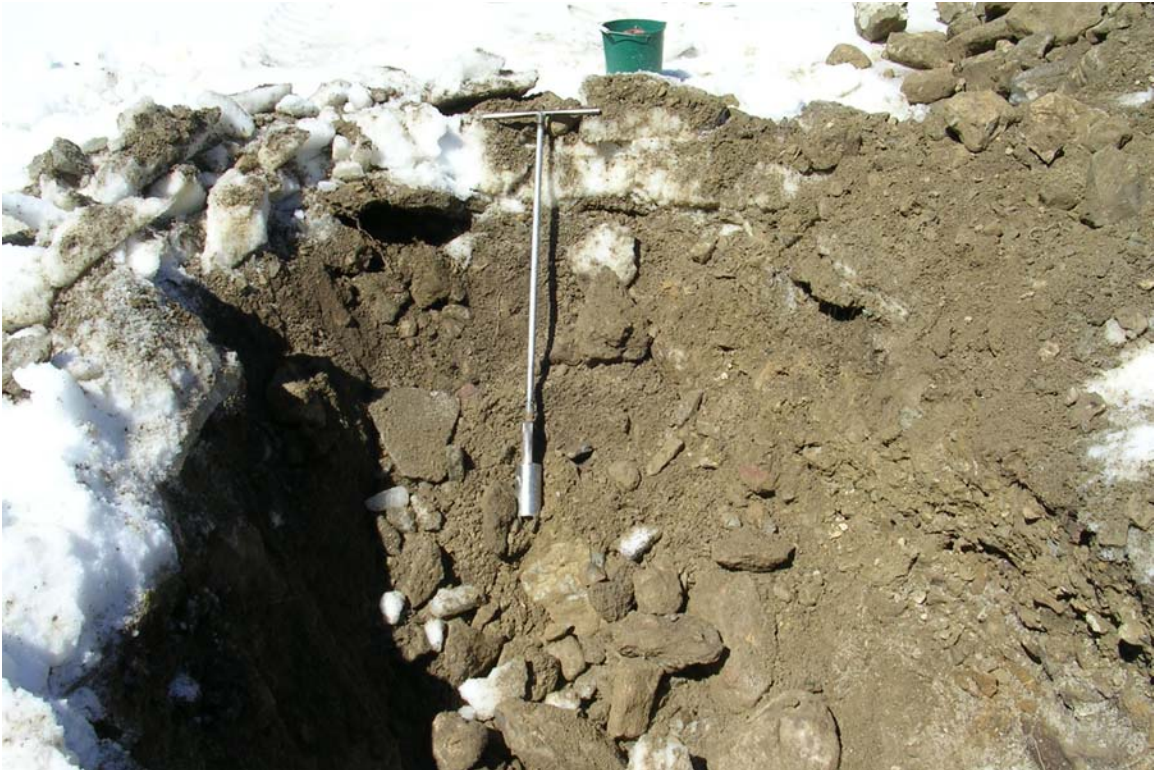
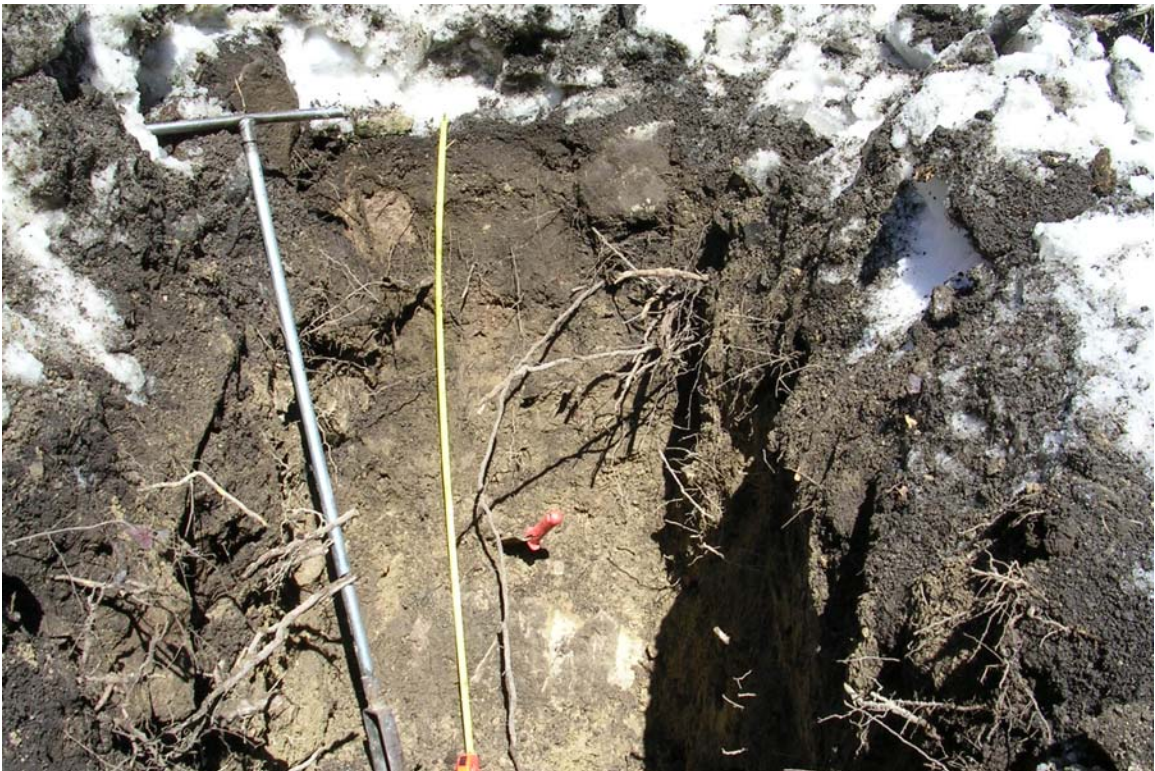
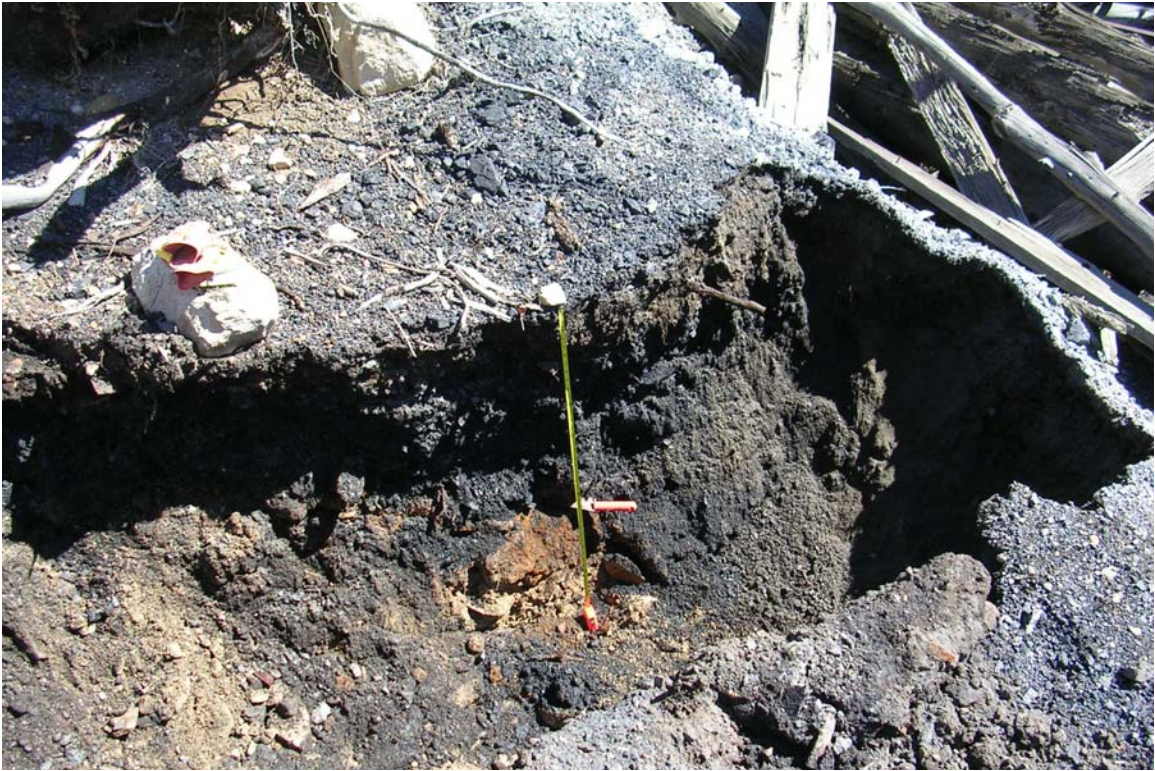
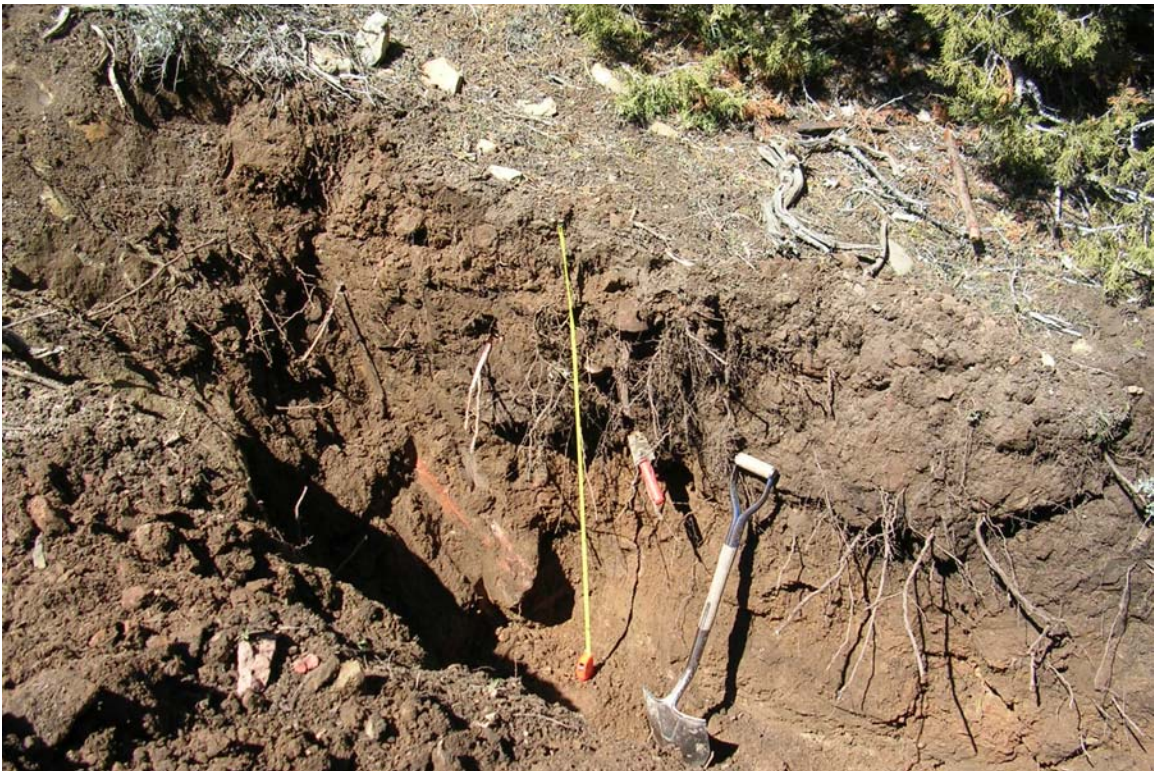
Trench E-1 located in a disturbed pad near drainage on north end of site, covered with 8 inches of snow. Profile of E-1: 0-3' disturbed soil mixed with coarse fragments, approximately 50% boulders, 20% cobbles, 10% gravels. 3 - 5' loose sand (buried C horizon).

Trench E-2 in native soils on west side of existing road, on level flood plain above creek. Maples, mahonia and sage vegetation covered with 8 inches of snow, so difficult to tell the extent of the surface litter layer. E-2 profile: A1 0 - 5 inches, friable, coarse granular, loose, many roots, high organic matter, moist color 10YR2/1. A2 5 - 17 inches, same as above, but less OM and moist color 10YR3/2/. B1 17 - 36 in. many roots, blocky, moist color 10YR4/3. C 36 - 48 in loose very fine granular sand with 10% gravels, moist color 10YR5/3. All horizons were sampled for lab analysis from Trench E2. Trench E2 represents the undisturbed soils east of the road.

W1 was located in undisturbed soil above existing road and below previous road disturbance. Snow absent from this location. Profile of W1: O horizon 0 - 3 in. organic material. A1 3 - 23 in loam, many roots, friable, granular, moist Color 10YR2/2. B1 20 - 39 in, sandy loam, some roots, loose granular moist color 10YR4/4. B2 39 - 54 in. sandy loam, some roots, firm, blocky, moist color 10YR4/4 (aside from the structure in B1, the B1 and B2 layers are the same). All horizons were sampled for lab analysis from Trench W1. This pit represents the undisturbed soils on lesser slopes next to the road.

A trench into the coal waste by the tippel on the east side of the road revealed the following: surface 0 - 27 inches coal (in places 36 inches), loose granular, 7 - 10% gravels, moist color 10YR2/1, dry color 10YR3/1. 27 - 35 inches, reddish oxidized sandy loam lens, moist color 5YR3/4. 35 - 48 inches, sand - buried C horizon. Coal waste and oxidized material sent for laboratory analysis.

Coal waste of west side of road (loose granular, 7 - 10% gravels, color 2.5YR2/0) also sampled for laboratory analysis.
